Safety Flash: Incident with Property Damage

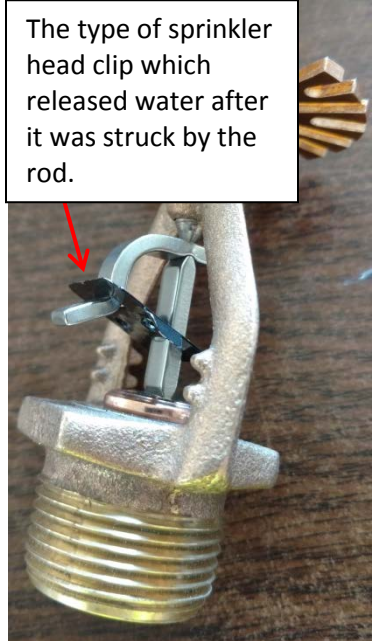
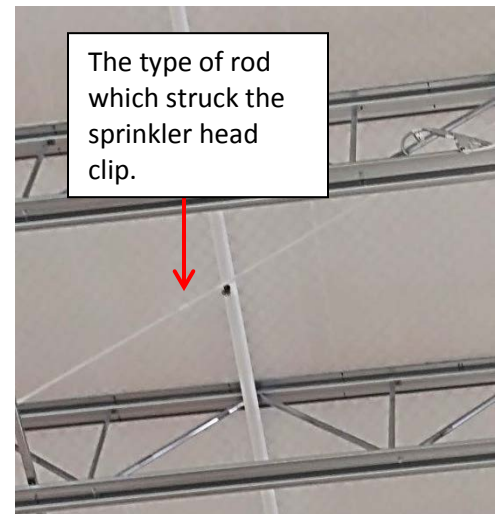
Incident: An ironworker was working in a man-lift at roof height when his arm bumped a connecting rod which hit the sprinkler head. The head opened and discharged water into the building.

- Work being performed was added to our original scope.
- The sprinkler head was installed immediately adjacent to the connecting rod and positioned so the protective hoop was parallel to the connecting rod, exposing the head to damage.
- BIM was not used on the project to identify potential conflicts before work began.
- The worker installing the sprinkler head didn't recognize that it was in close proximity to the building members and didn't bring it to anyone's attention.

- The worker installing the sprinkler head didn't recognize that it was in close proximity to the building members and didn't bring it to anyone's attention.

- Verify that sprinkler heads have been installed with enough clearance.
- Make sure nothing is in contact with sprinkler heads.

- RLI spoke to the subcontractor about sprinkler heads being installed against building components.
