Safety Flash

Near Miss Incident

Date of Incident: 12/12/2018

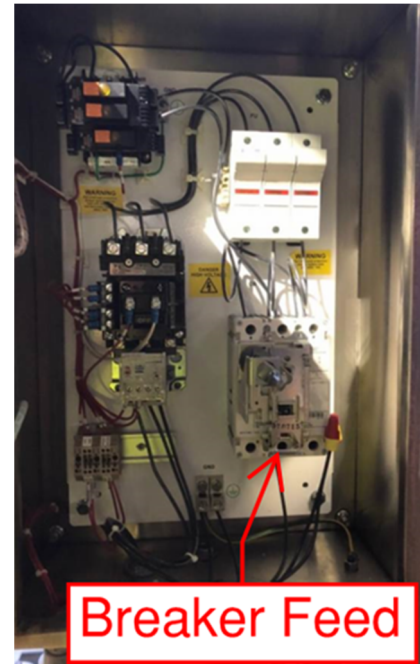
While replacing a motor on a blower skid, an associate discovered that the new motor rotation needed to be reversed. When he attempted to reverse the wires, he received an electrical shock.

- The breaker in the OEM-supplied cabinet is bottom-fed. The industry standard is typically top-fed.
- Per the customer requirements, the outside of the cabinet should have been labeled to identify the bottom-fed breaker.
- The associate failed to verify that the wires were de-energized before starting work.
- The crew felt rushed because they were informed late in the day that they needed to complete their work by the end of their shift.

- Always verify that the equipment has been de-energized and locked out before starting work.
- "Take 2" for safety and evaluate your work area for unusual conditions and/or potential hazards.
- Discuss the work plan with your coworkers to identify hazards.

- A safety stand-down was performed with all associates on site.
- Safe electrical work practices were reviewed with the crew.
