## Safety Flash – Incident with injury

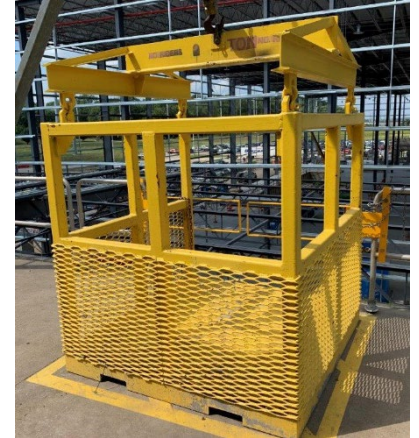
**Incident:** The subcontractor crew was pouring concrete pads on the roof of the existing building. Concrete was being placed in two wheelbarrows on the hoisting platform to be raised to the roof. As one wheelbarrow filled up with concrete, the worker used a shovel to stop the flow in the chute and backed up the concrete truck to swing the chute to the other opening. As the truck pulled forward, his hand was pinched between the shovel handle and the hoist frame.

- The worker held back concrete in the chute with a shovel when moving the chute to avoid spilling concrete onto the plant-owned hoist.
- A vertical bar in the middle of the hoisting platform required the truck to reposition to move the chute instead of swinging the chute to fill the second wheelbarrow.
- The worker did not recognize the potential pinch point created when he placed his body in the line of fire as he moved to the next opening.
- The crew did not see the need to complete another daily pre-task plan to identify hazards and work methods because they had completed the same task previously.
- The crew did not realize they could rotate the hoisting platform for unobstructed access to both wheelbarrows instead of moving the concrete truck.

- The crew did not realize they could rotate the hoisting platform for unobstructed access to both wheelbarrows instead of moving the concrete truck.
- The crew did not see the need to complete another daily pre-task plan to identify hazards and work methods because they had completed the same task previously.

- To eliminate the pinch point, consider turning the hoist to fill the wheelbarrow on the side with no middle bar.
- Perform twice daily pre-task planning per our contract.
- Consider using other types of hoisting equipment.
- Provide training on pinch point hazards.

- The subcontractor met with the field crew to discuss the incident, mentoring of new employees and pinch point hazards.
- The worker involved in the incident has taken 30-hour OSHA training.
- The subcontractor's goal is to require 30-hour OSHA training for all foremen.
- RLI met with all crews on site to discuss pinch points/caught-between hazards and the Find It-Fix It program.
- The subcontractor's safety director will continue weekly site visits.
