HVAC EQUIPMENT RISK ASSESSMENT

SAMPLE REPORT

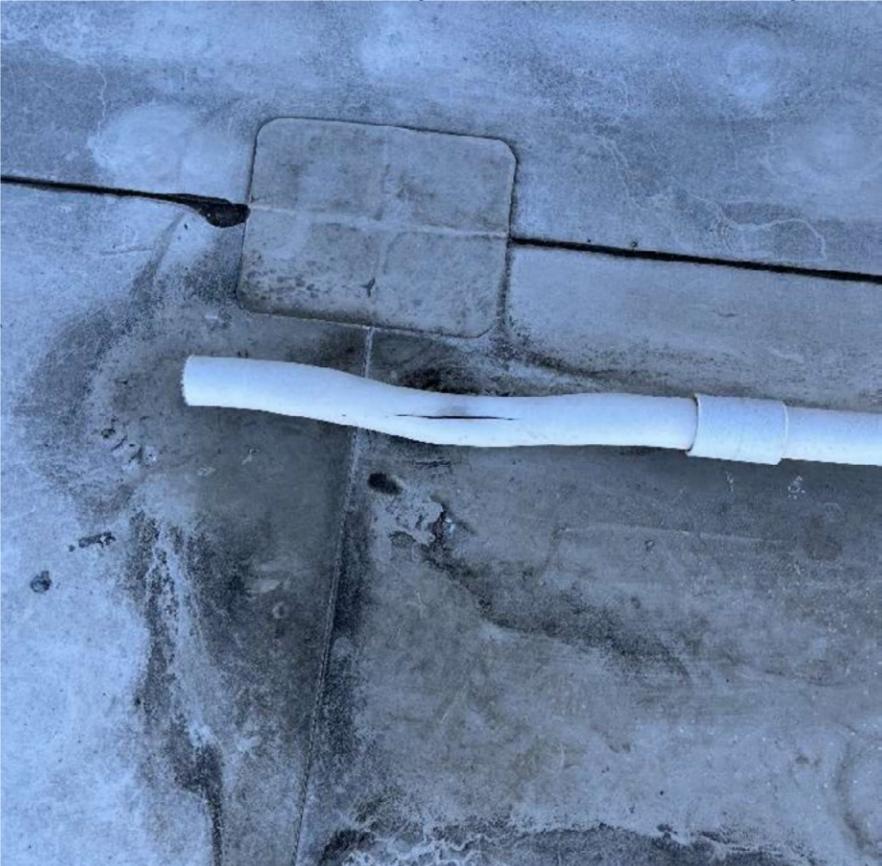
FINDING: Cracked condensate drain trap.
EFFECT: Condensate may drain improperly and overflow into building. Air can flow through drain, increasing heating and cooling requirements and energy usage.

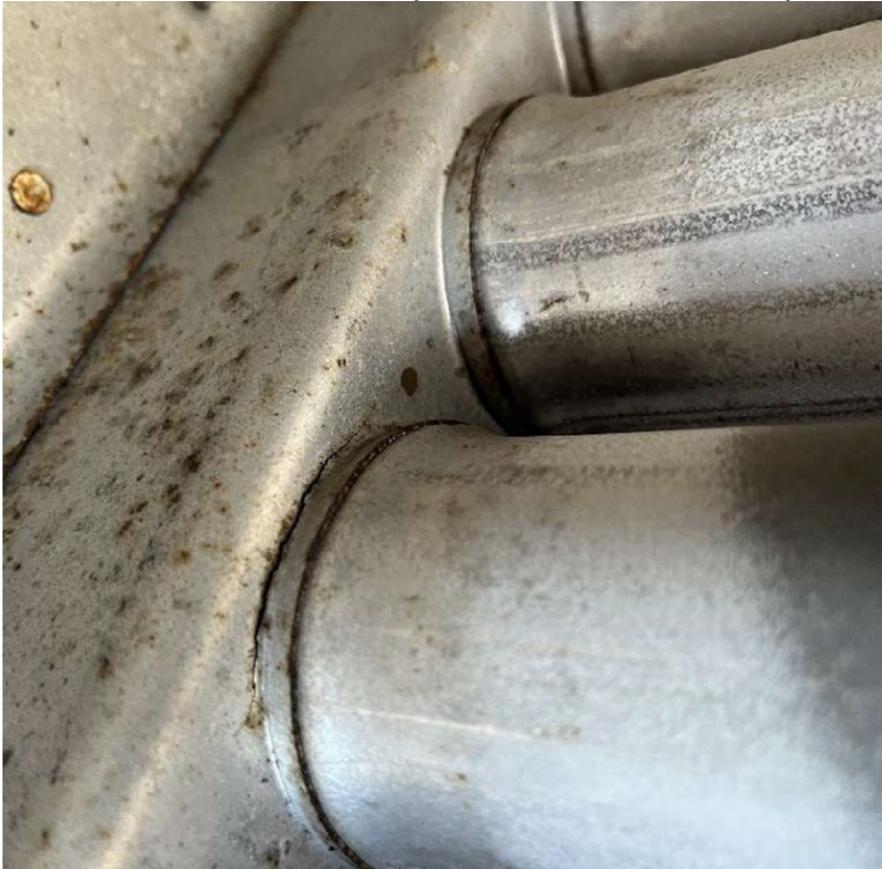
FINDING: Cracked heat exchanger.
EFFECT: Unit was shut down and heat exchanger subsequently approved for replacement.

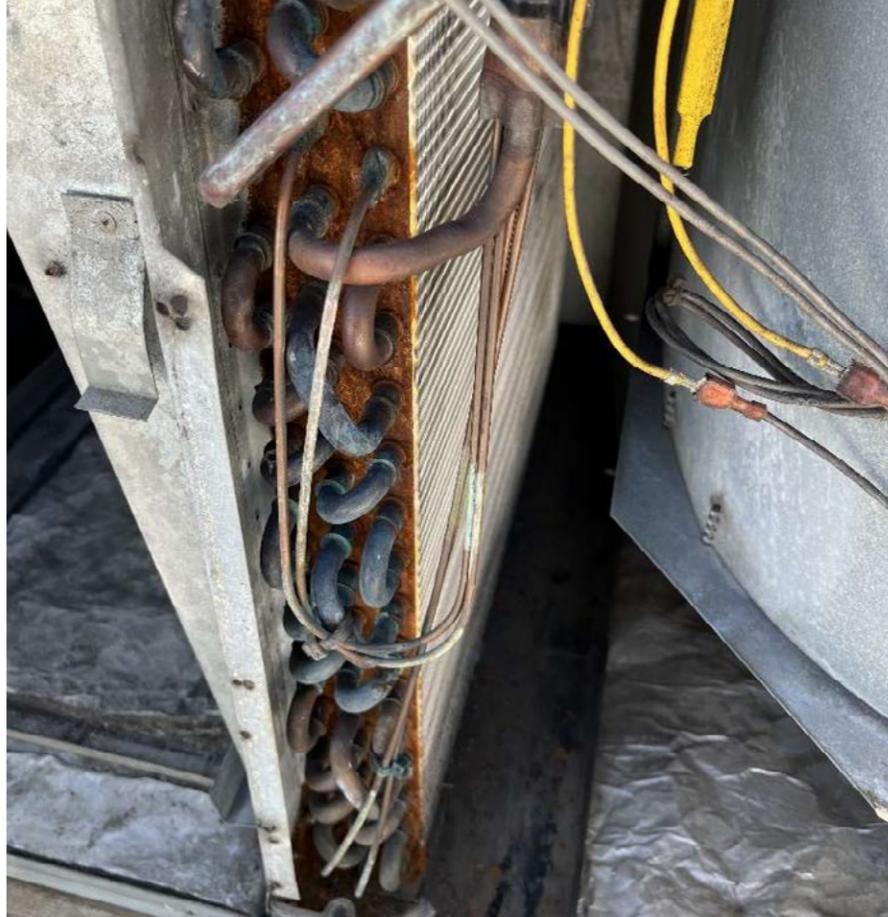
FINDING: Rusting of evaporator tube sheets.

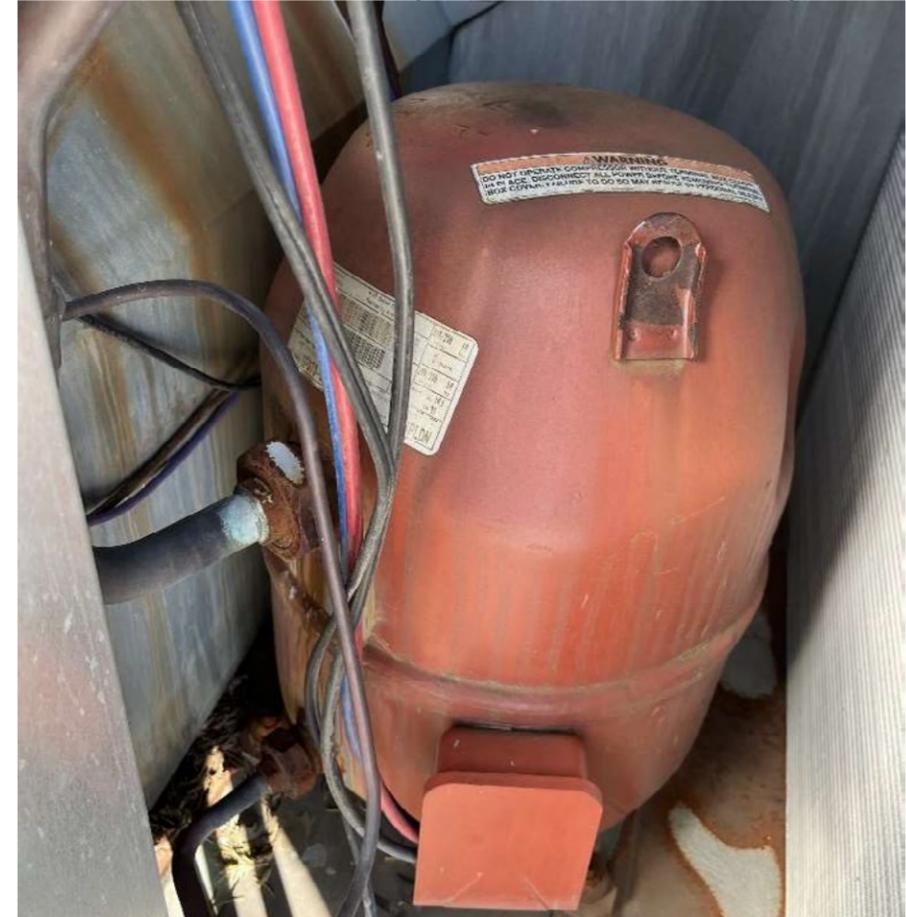
FINDING: Appears to be original 25 year old compressor.

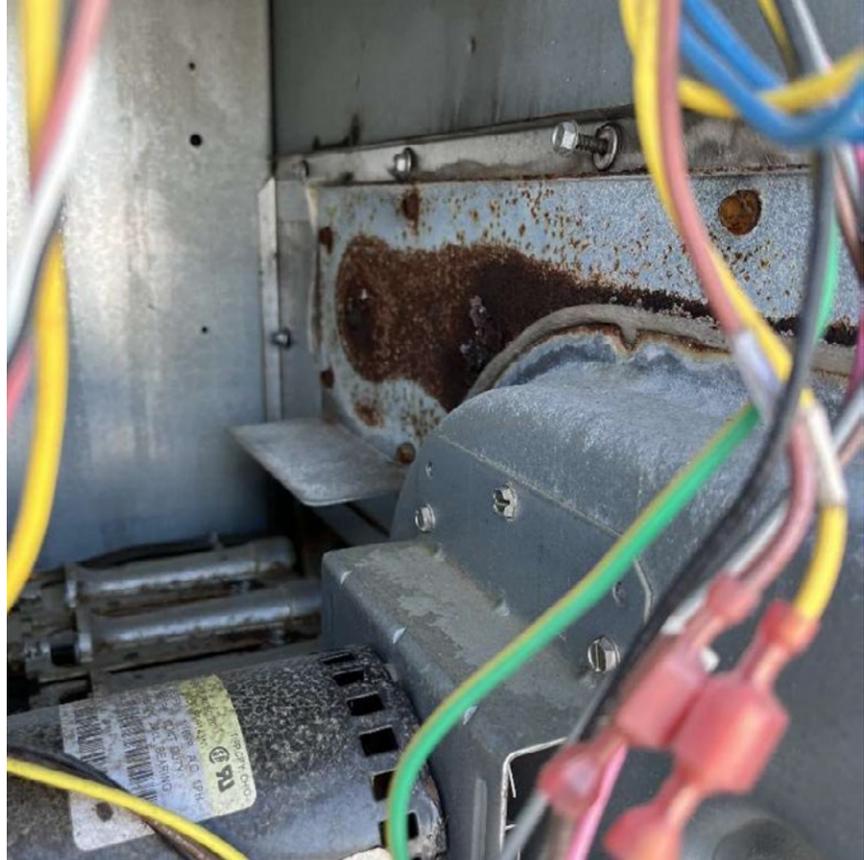
FINDING: Significant rust of heat exchanger wall.

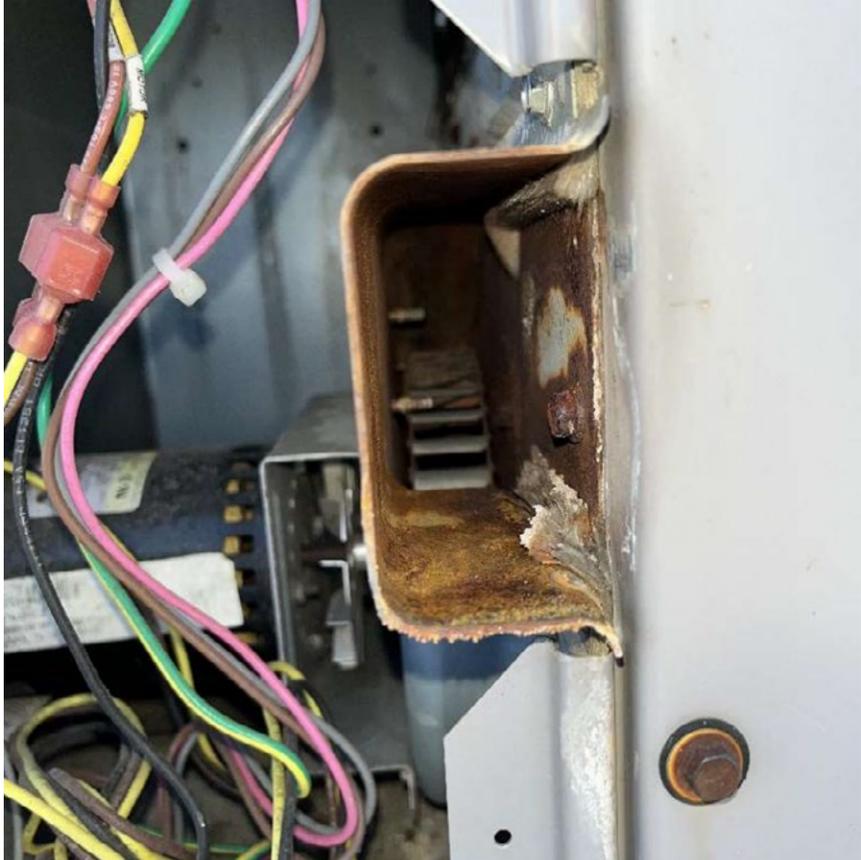
FINDING: Significant rust of inducer fan.

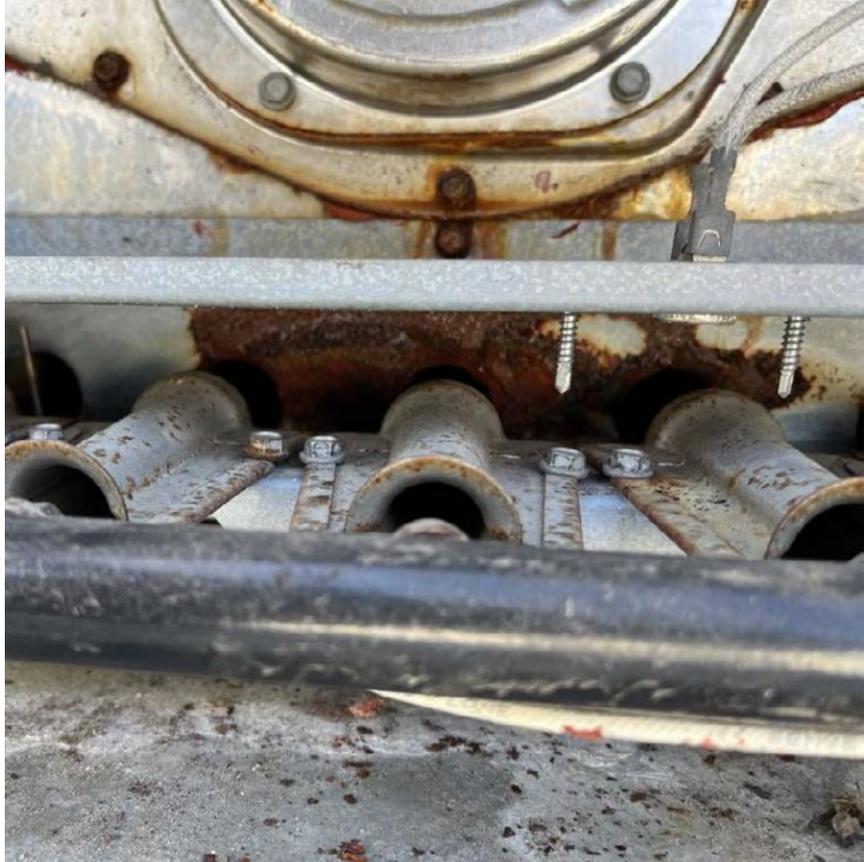
FINDING: Significant rust of heat exchanger wall.

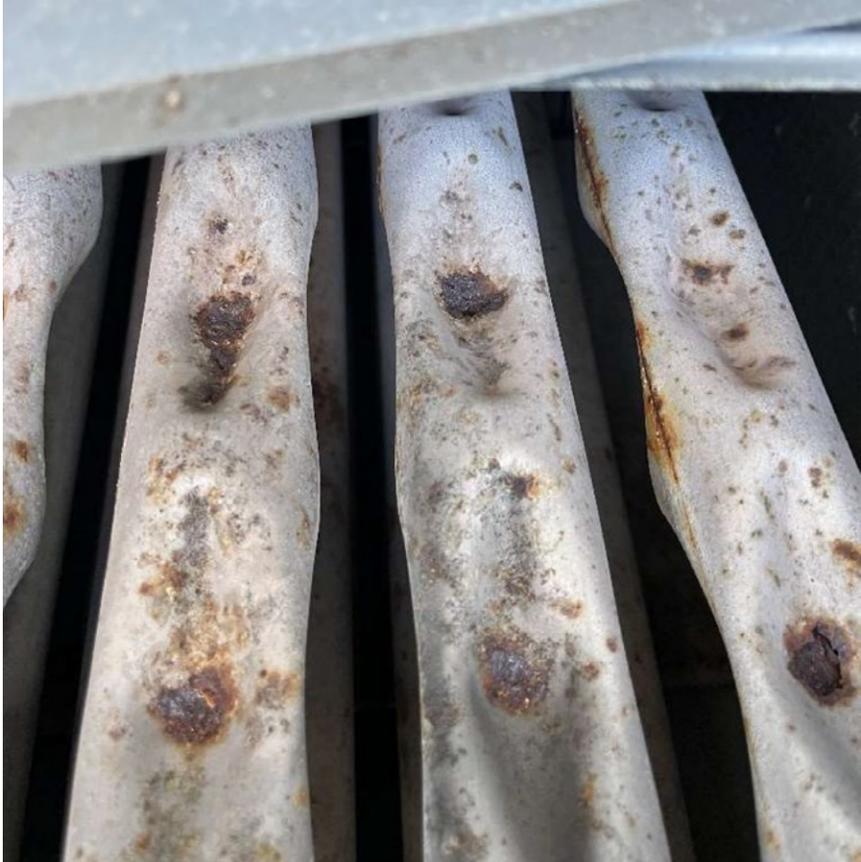
FINDING: Failed heat exchanger with at least two holes in dimpled areas of heat exchanger.

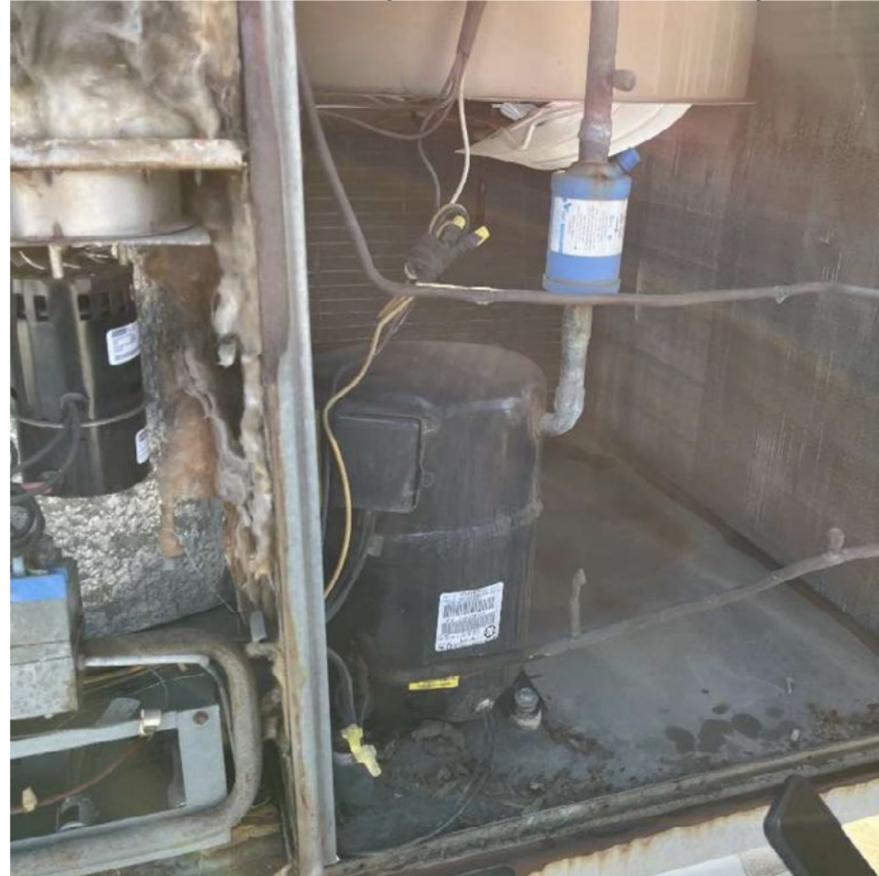
FINDING: Old compressor, probably replaced at least once before.

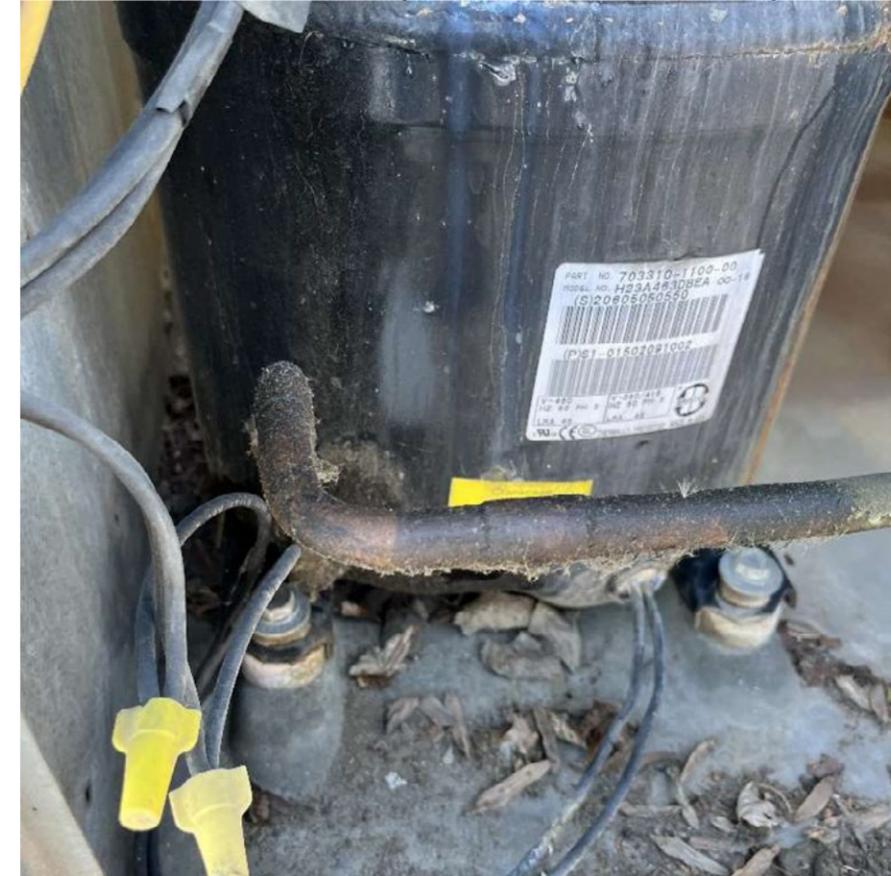
FINDING: Possible refrigerant leak, indicated by oil on refrigerant piping.

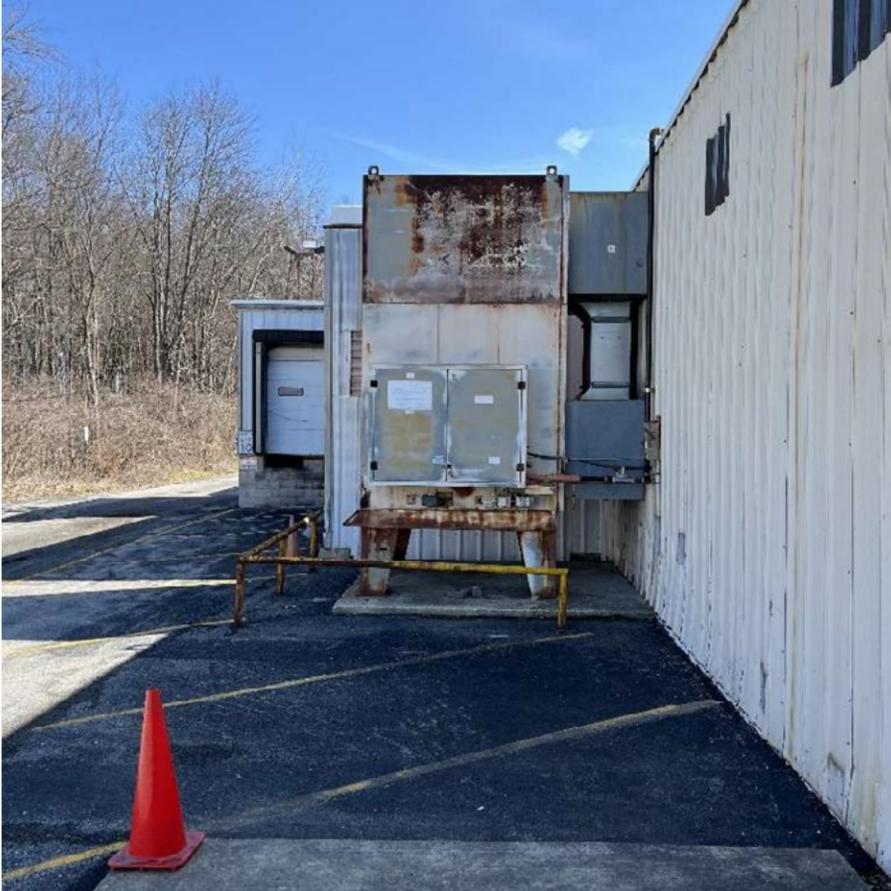
FINDING: Unit beyond the typical useful life and in very poor condition.

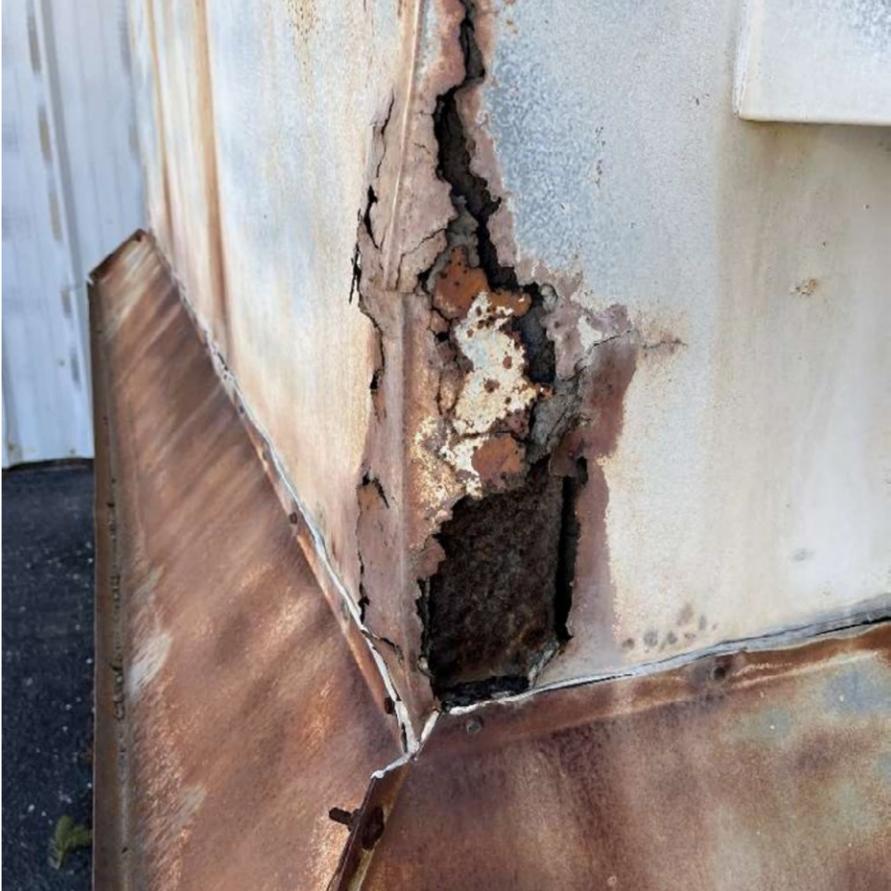
FINDING: Unit beyond the typical useful life and in very poor condition.
