Safety Flash: Near-miss incident

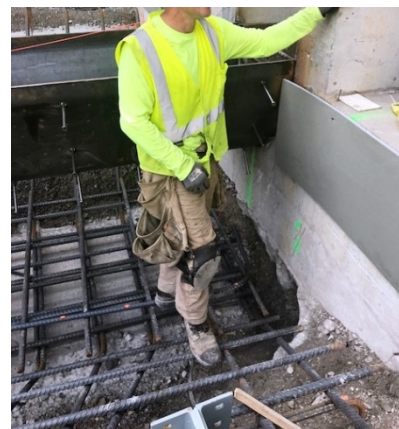
Incident: After finishing layout work, an RLI carpenter was walking up the bottom rebar mat to exit a 2-foot-deep sloped excavation for a flume. He placed his hand on a 3-foot-high concrete foundation to stabilize himself, then moved his hand to the double-stacked steel beams on top of the concrete. When he saw the steel beams were becoming unstable, he stepped backward out of the line of fire as the top beam rolled into the excavation, landed upright and displaced two pieces of tied rebar. The rebar pushed against the carpenter's leg, but the beam did not hit him and he was not injured.

- The carpenter put his hand on the steel for support, causing the top beam to topple.
- The top-heavy beams – 6 inches wide, 18 feet tall and 9 feet long – were double-stacked due to limited storage area.

- Photos show the beams were initially properly placed with three pieces of cribbing, but for unknown reasons, the cribbing was later reduced and moved to an angle that no longer provided support, with only two pieces of different heights under and between the beams – one on the end and the second piece about 3-4 feet away, leaving the other end of the beams unsupported.

- Consider single-stacking or laying down narrow I-beam pieces on the flat side.
- Inspect laydown areas more often to identify and correct changes in site conditions that can make stored materials unstable.
- Make sure all material used for cribbing is the same size.
- Make sure everyone on site understands how to identify and eliminate hazards created by improperly stacked steel and materials.

- A stand-down was held to review proper material handling and storage methods, and the importance of periodic inspections of laydown areas.
