Safety Flash - Incident with Property Damage

Incident: A loader backed over the hood of a utility vehicle, damaging its windshield. The laborer driving the utility vehicle had told the operator to backfill around a manhole a short distance away. Then the laborer made a U-turn and drove to the right of another manhole nearby.

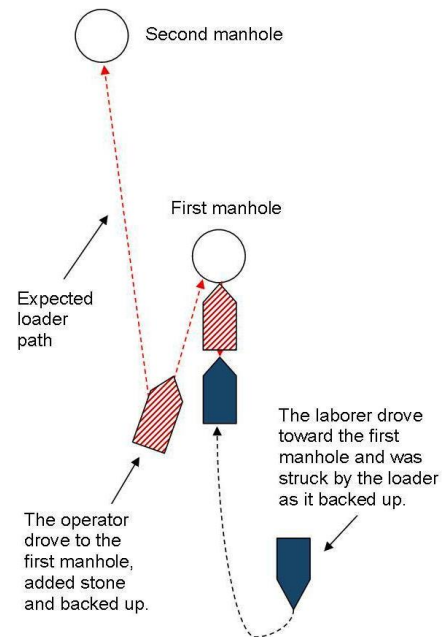
The operator added stone to the first manhole. Before back-dragging, he checked the backup camera screen and didn't see anything. The laborer was directly behind the loader when it started backing up and struck his utility vehicle.

- The utility vehicle was too close behind the loader to move out of the way.
- The operator and laborer miscommunicated about which manhole should be backfilled and when – the laborer asked the operator to backfill the far manhole immediately, and the operator decided to add stone to the closest manhole first.
- The laborer was driving the utility vehicle to the right of the first manhole, and thought the operator was driving to the left.
- The operator's view behind the loader was in the shade of the machine and the camera picture was not clear.
- The operator and laborer had been working together and were possibly complacent.

- The operator and laborer miscommunicated about which manhole should be backfilled and when – the laborer asked the operator to backfill the far manhole immediately, and the operator decided to add stone to the closest manhole first.

- Make sure crew members communicate clearly with each other.
- Make sure workers are aware of their surroundings and how close they are to equipment and activities in the area.
- Don't follow mobile equipment too closely and give yourself room and time to react.
- Make sure you can see mirrors.

- A jobsite stand-down was held with all crews to discuss blind spots.
- The RLI annual safety meeting addressed working around equipment and blind spots.
- Training will continue on working around mobile equipment.
