Safety Flash

Incident with Recordable Injury

Date of Incident: 11/18/2024

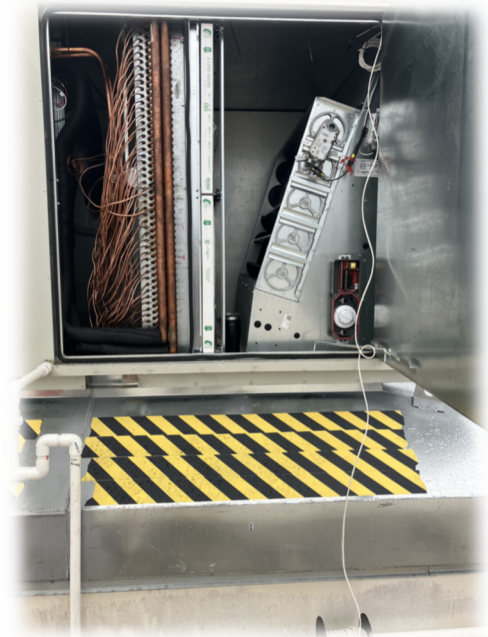
An associate was standing on an angled curb of a roof top unit (RTU). As the associate was working on the open unit they slipped and started to fall forward towards the unit. As the associate reached up to catch themselves, they cut their hand on the exposed sharp metal of the RTU door frame.

- Proper hazard identification of the angled curb during the job walk down in the estimating process was not done.
- The hazard was not identified before work began.
- Traction tape was not installed before work began.
- No STAC card was filled out prior to beginning work.
- Associate initially was wearing proper gloves, but had just removed one glove for dexterity. And that was the hand that was injured.

- GEM's paper STAC cards to be used as the only pre-planning tool for this department for the foreseeable future.
- STAC cards will be turned in and reviewed by the superintendent of the department every Friday.

- On Friday, November 22, 2024, department associates will receive supplementary training on the completion of a STAC Card, along with a discussion on its significance in effectively identifying hazards. Additionally, there will be a review of Take 2 for Safety.
